Return 50 Bernardo

CA PFH 81-1(1)

Inyo National Forest, Mono County, California

FINAL PAVEMENT REPORT April 14, 2004

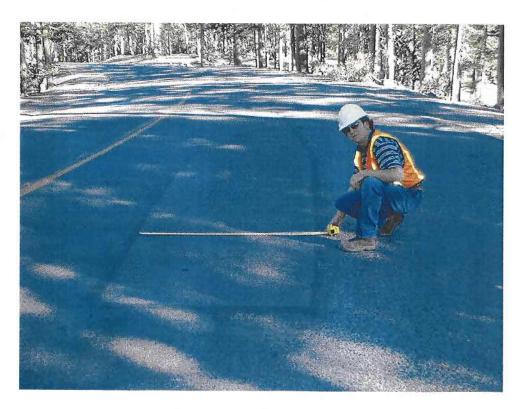
Mile Marker (miles)	Paved Road Width (feet)	Pavement Thickness (inches)	Road Base Thickness (inches)	Pavement Condition
0.0 to 0.1	~22	4.00	6.0	Low to moderate longitudinal and transverse cracking. Patched areas. Moderate to high edge cracking; failure of EOP.

Photograph 2 (MM 0.0 to 0.1): Low to moderate patching.

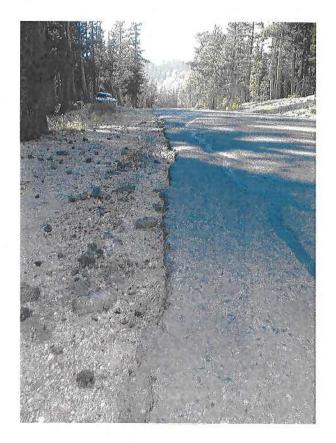
0.1 to 0.4	~24	4.27 (2.5 @ pullout)	6.0-8.0	Low to moderate longitudinal and transverse cracking. Moderate to high severity raveling - 2 feet by 2 feet. Moderate to high edge cracking; failure of EOP. Patched edge areas present. Paved pull-out area with patching.

Photograph 3 (MM 0.1-0.4): Moderate to high edge cracking and EOP failure.

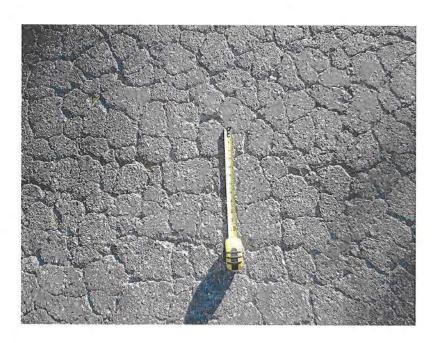
0.4 to 1.0	~22	4.00 to 4.27	6.0-8.0	Low to moderate longitudinal and transverse cracking. Moderate to high edge cracking. Moderate to high fatigue cracking. Low to moderate potholes.

Photograph 4 (MM 0.4 to 1.0): Moderate to high fatigue cracking.

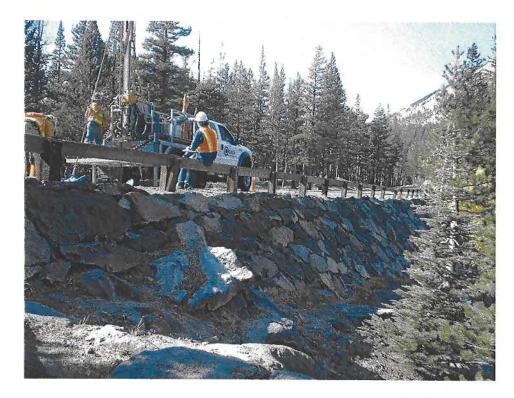
Photograph 5 (MM 0.4): Drill rig set up on P-2 on a fill section.

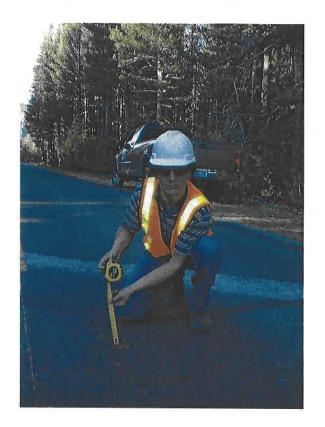
1.0 to 1.5	~22	4.27 to 5.00	9.0	Low to moderate longitudinal cracking. Low to moderate edge cracking. Polished aggregate. Low to moderate potholes.
1.5 to 2.0	~22	3.69 to 5.00	6.0- 7.0	Low to moderate longitudinal and transverse cracking. Moderate to high edge cracking. Moderate to high severity raveling - 4 feet by 6 feet. Low to moderate potholes.

Photograph 7 (MM 1.0-1.5): Low to moderate potholes.

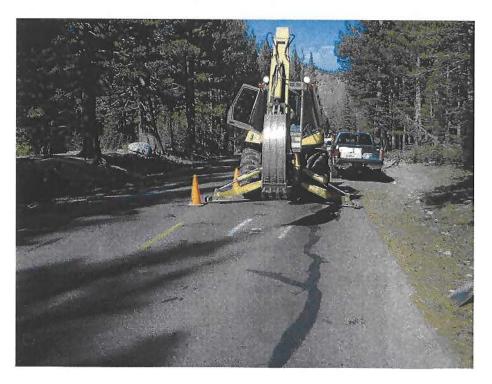
A test pit was excavated near MP 1.4 (see Appendix C, Photo 8). A total of 100 lbs of pavement, base and sub-base bulk samples were collected. The excavation was backfilled with imported structural fill and cold patched.

Photograph 8 (MM 1.4): Test pit excavation.

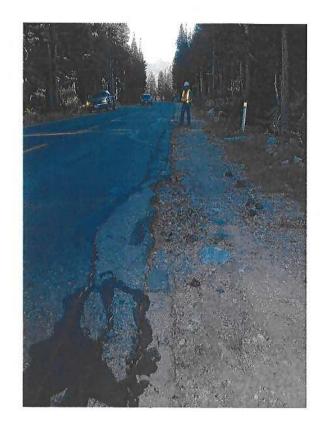
Photograph 9 (MM 1.5-2.0): Moderate to high edge cracking.

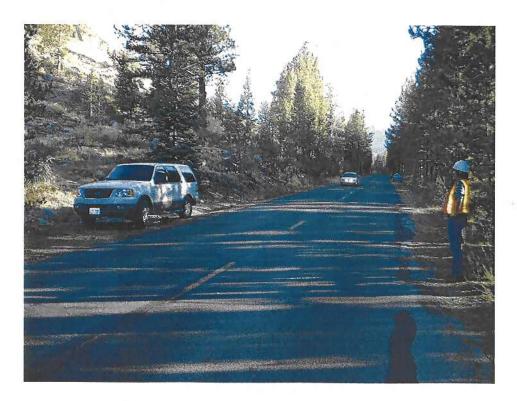
The natural slopes are approximately 1-1/2H:1V and are probably near the angle of repose of the colluvial material. As recommended in the scoping report, future cuts, if needed, should be less than 34 degrees (estimated colluvial material internal friction angle) to ensure long-term global stability. Precipitation and frost-heave processes may be responsible for surface raveling, which should be taken into account in future cut areas by the use of a wider shoulder or catchment ditch.

Photograph 10 (MM 1.7): Cut slope location.

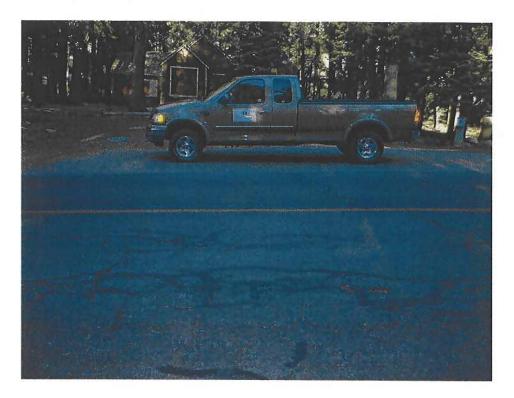
2.0 to 2.7	~22	4.35 to 4.50	6.0-12.0	Low to moderate longitudinal and transverse cracking. Low to moderate reflection cracking. Low to moderate edge cracking. Low potholes.

Photograph 11 (MM 2.0-2.5): Low to moderate reflection cracking.

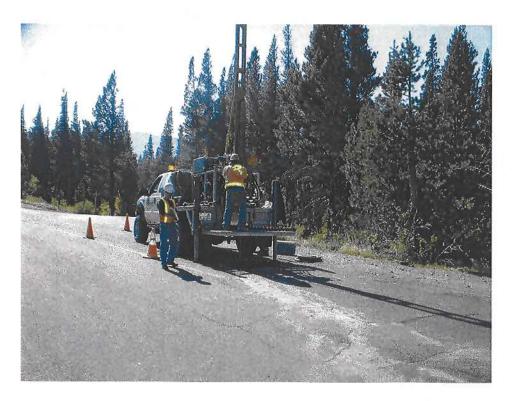
Photograph 12 (MM 2.5): Drill rig set up on P-7.
